Manhole Inspection Summary

Manhole # S17AA1B01MH

Record Plat: **17AA1** Node: **B01** Status: **New Manhole (Not in GIS)** Insp Date: **6/4/08 12:00 AM**

Location Address: **GREENSRING AVE**

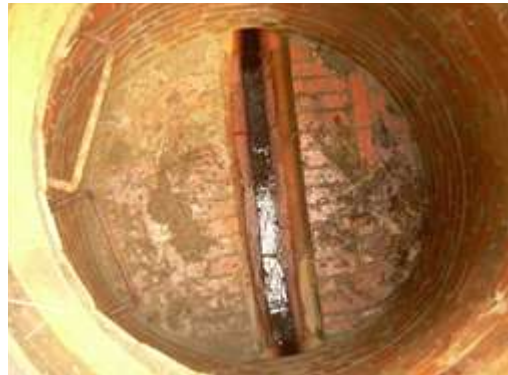
Top View

Barrel infiltration. Evidence of surcharge - Bench debris.

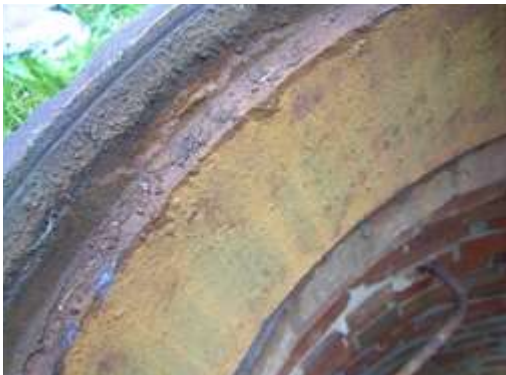
Defect

Frame leaks. Corbel infiltration.

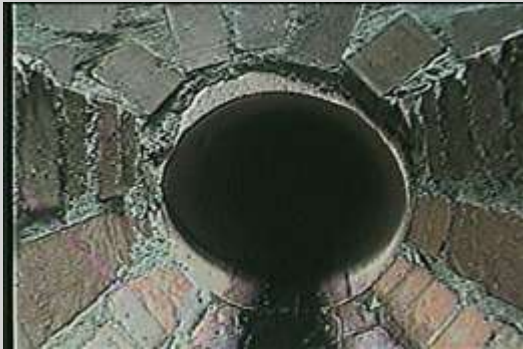
10 in. Circular Gravity Sewer Pipe Out @ 12 O'Clock

Pipe Material: **Clay** ☐ Pipe Lined

Invert Depth: **6.35** (ft.) Flow Characteristics: **Slow**

Deposits: ☒ None ☐ Mud ☐ Sludge ☐ Debris ☐ Grease

Infiltration: **None** Pipe Seal Cond: **Unknown**

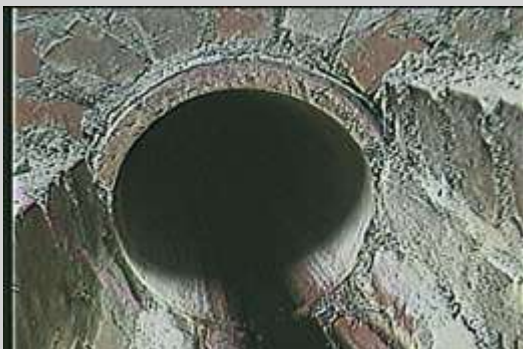
10 in. Circular Gravity Sewer Pipe In @ 6 O'Clock

Pipe Material: **Clay** ☐ Pipe Lined

Invert Depth: **6.05** (ft.) Flow Characteristics: **Slow**

Deposits: ☒ None ☐ Mud ☐ Sludge ☐ Debris ☐ Grease

Infiltration: **None** Pipe Seal Cond: **Sound**
